FINAL INSPECTION REPORT

**4450 North South Street
Bozeman, Montana**

Date: 10/9/2009	Time: 2:30 PM	Report ID: 100.200
Property: 4450 North South Street Bozeman, Montana	Customer: Samantha and Sam Sample	Real Estate Professional: Jenifer Owens REMAX REALTY GROUP

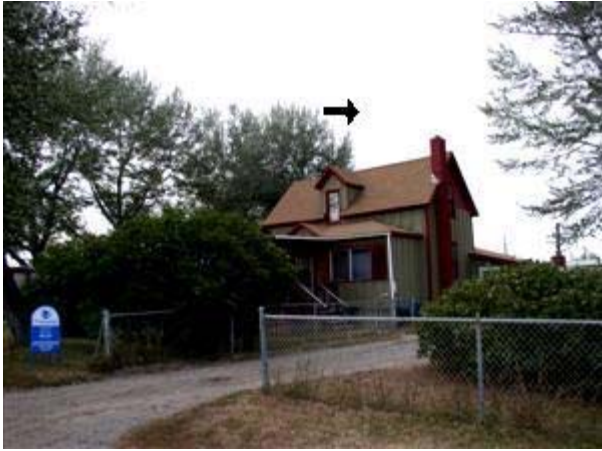
1.0 Picture 1

1.0 In general the property sloped downward toward the north.

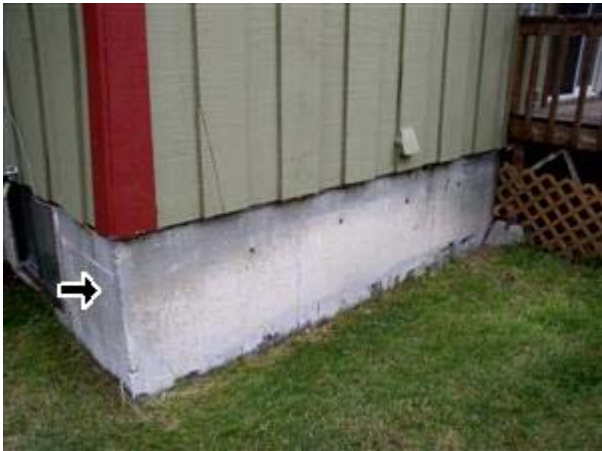
1.10 Picture 1

1.10 This older home was set on a newer foundation system.

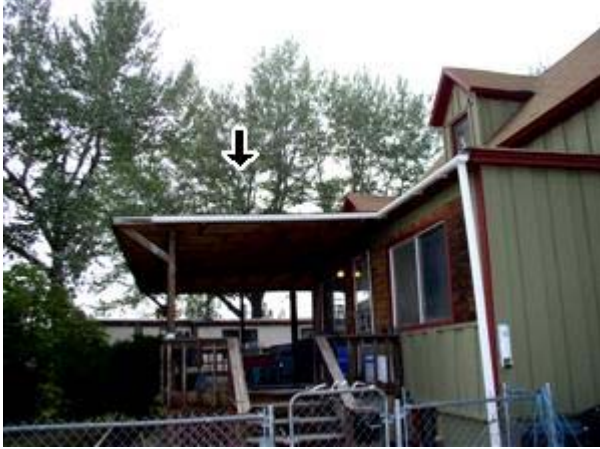
2.0 Picture 1

2.0 Although generally functional this roof had shingles at the front porch that were placed on a roof slope with less than a 4/12 pitch. This may require above average maintenance during the life span of the roof.

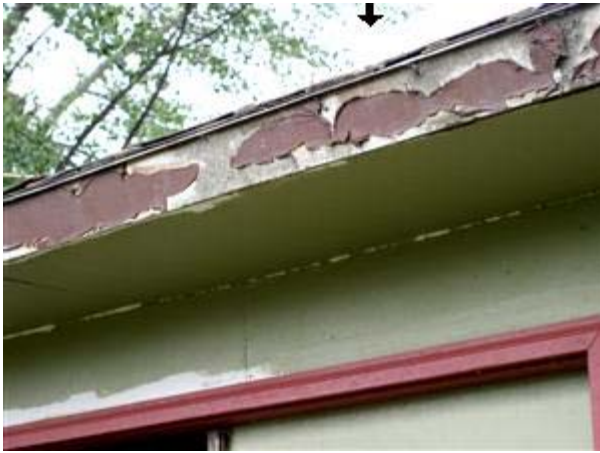
4.2 Picture 1

4.2 Some siding was weathered. Coatings are recommended.

Some siding was weathered. Coatings are recommended.

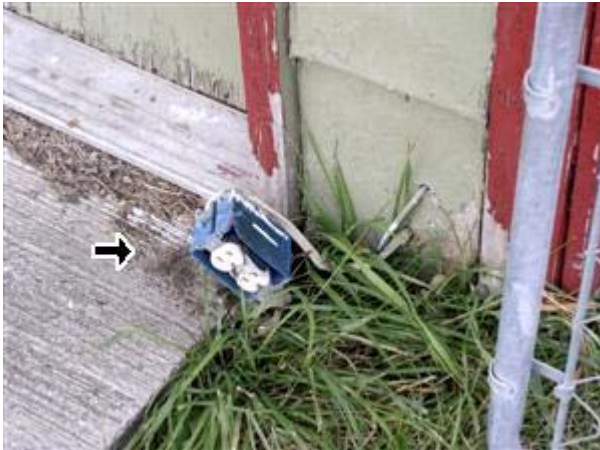
4.11 Picture 1

4.11 Several junction box covers were missing. Covers are recommended.

There was an uncovered "interior" box at the south east corner of the structure. Enclosing these wires within an approved waterproof box is recommended.

Several junction box covers were missing. Covers are recommended.

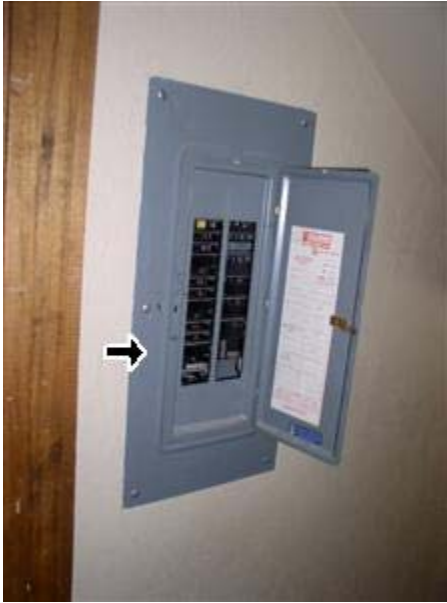
7.5 Picture 1

7.5 There was an "open" knock out hole in the panel box. A cover over this hole is recommended.

There was an "open" knock out hole in the panel box. A cover over this hole is recommended.

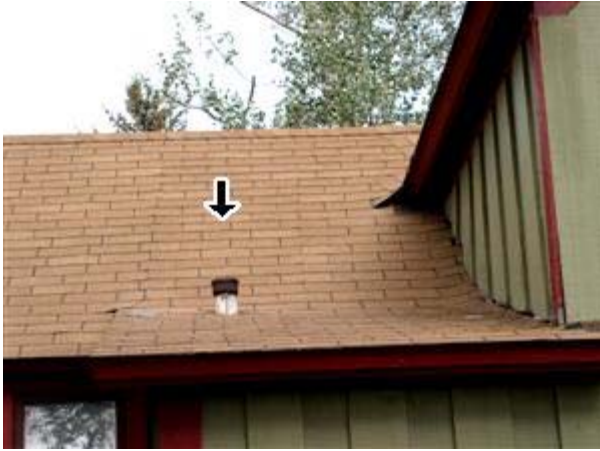
8.4 Picture 1

8.4 A plumbing vent stack at the south roof was not an appropriate height. Extending this to an appropriate height is recommended.

A plumbing vent stack at the south roof was not an appropriate height. Extending this to an appropriate height is recommended.

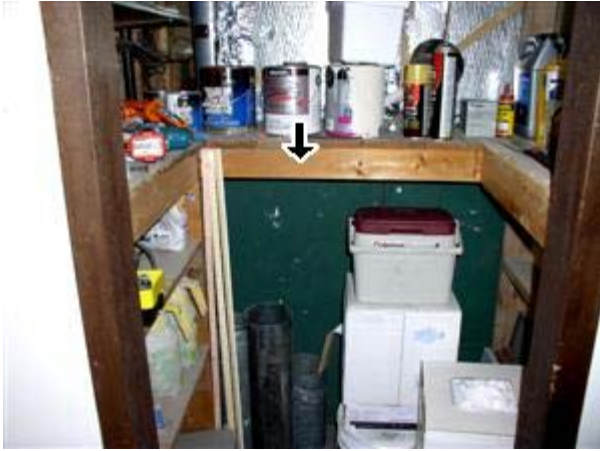
9.0 Picture 1

9.0 Access to this furnace was blocked by interior walls and built in shelving. This may be challenging during an emergency. Efficient and effective access is recommended.

Access to this furnace was blocked by interior walls and built in shelving. This may be challenging during an emergency. Efficient and effective access is recommended.

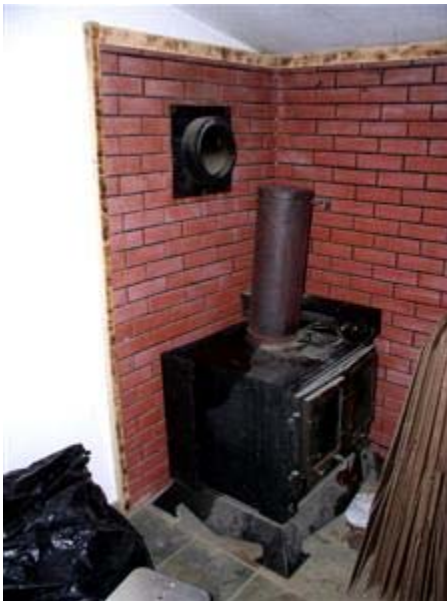
9.8 Picture 1

9.8 There was a wood stove in the north west corner of the north addition. It's flue pipe was disassembled and plugged. A flue cap was missing on the exit orifice.

There was a wood stove in the north west corner of the north addition. It's flue pipe was disassembled and plugged. A flue cap was missing on the exit orifice.

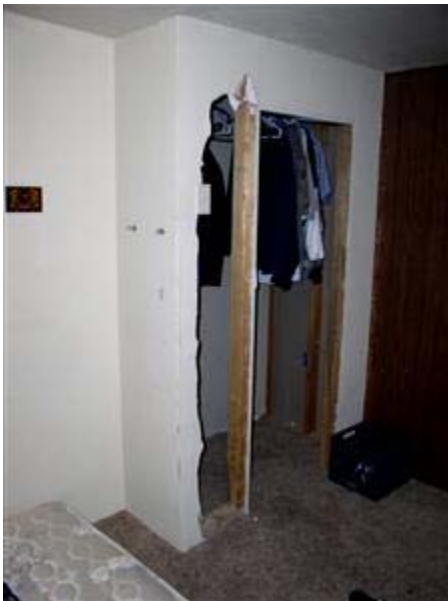
11.1 Picture 1

11.1 Some walls and window trim had not been completed and trimmed.
